MEASUREMENT OF IMPACT-DAMAGED AREAS IN COMMINGLED E-GLASS/POLYPROPYLENE LAMINATES VIA THERMOGRAPHIC IMAGES ANALYSIS

by C. Santulli

*University of Reading, School of Construction Management and Engineering
Whiteknights, Reading, RG6 6AY, United Kingdom*

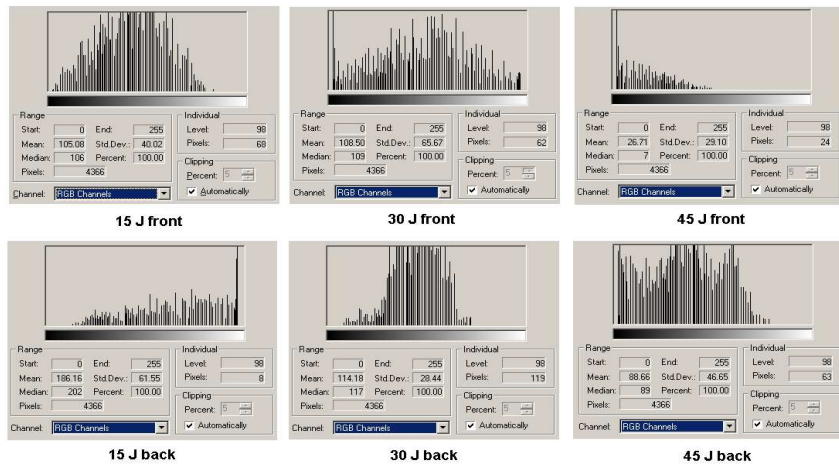
Figure 2 Grey level histograms for thermographic images (area 40x32 mm) of impacted 3-D commingled laminates

The method selected for image analysis, carried out using ©Corel Photo-paint software, involved using thresholding techniques by comparing the grey level histograms of the region of the samples including the impact area with the histograms of the remaining part of the laminate image (figure 2). A possible improvement of the method would include transforming the images on the greyscale and then subtracting pixel-by-pixel images taken at each impact energy, so to measure difference between impacted areas at the minimum energy (15 Joules) and at higher energies. This would possibly reduce the effect of the edges on the identification of the most suitable thresholding level for the images.

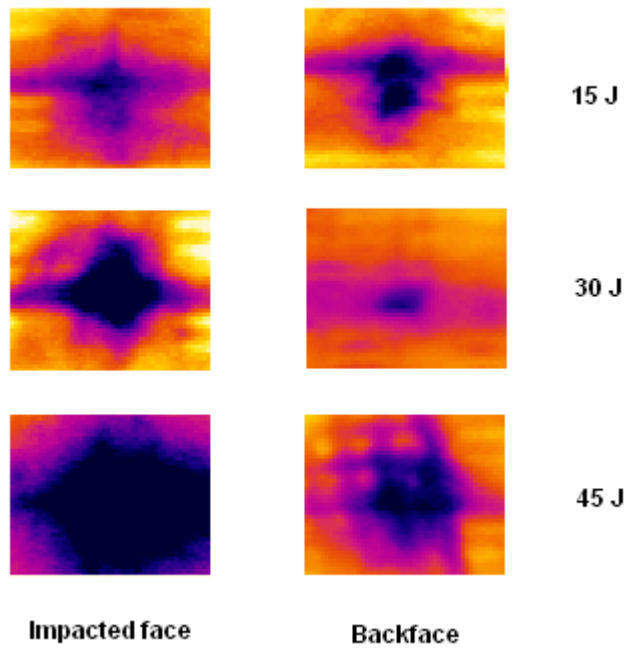
Figure 3 Typical IR thermography images of impacted areas in 3-D commingled laminates (40x32 mm area) (all of these images were acquired after 15 seconds transient)
