Alternatives for a hand lay-up composite structure: E-glass/epoxy adhesive joint or tapered laminate

C. SANTULLI

School of Engineering, University of Reading, Whiteknights, Reading RG6 6AY, UK
E-mail: c.santulli@reading.ac.uk

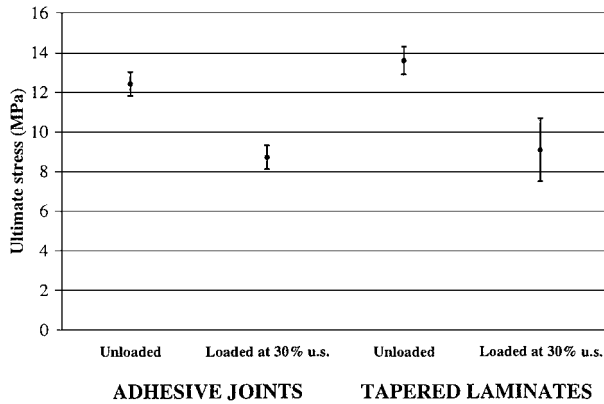
Figure 2 Tensile properties (initial and residual) of both structures.
